# FIELD INSPECTION REPORT

<b>Project Name:</b>	Mountain Valley Pipeline	<b>Inspector:</b>	Matthew Grant
<b>Inspection Date:</b>	Thursday, September 9, 2021	<b>Project Contact:</b>	Brian Clauto
<b>Spread H: Montgomery</b>	AR 28, 279.01 ATWS 645, 645A St12485-12460	<b>Weather:</b>	Wet

# FIELD INSPECTION PHOTO LOG

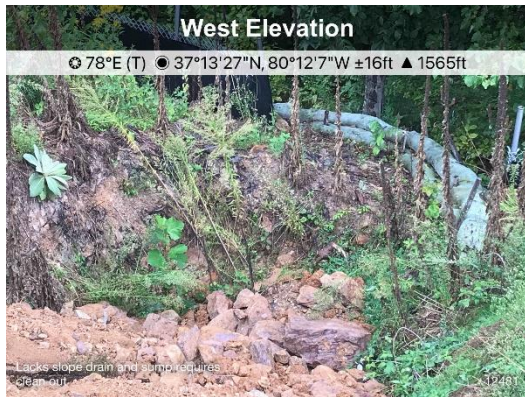
- St 12481 sump is over 50% capacity and requires clean out
- St 12481 fill slope to sump lacks slope drain
- St 12478+35 sump is over 50% capacity and CFS requires maintenance

- Figure 1: St 12481 sump requires clean out and slope lacks slope drain.

**Recommended Corrective Action:** Maintain and install all controls per the approved PSS&S.

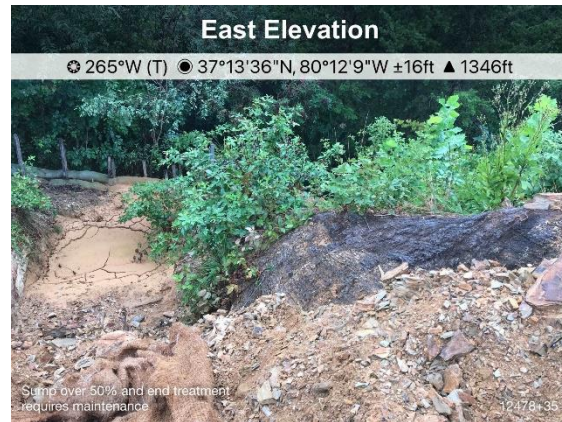
- Figure 2: St 12478+35 sump and CFS requires maintenance.

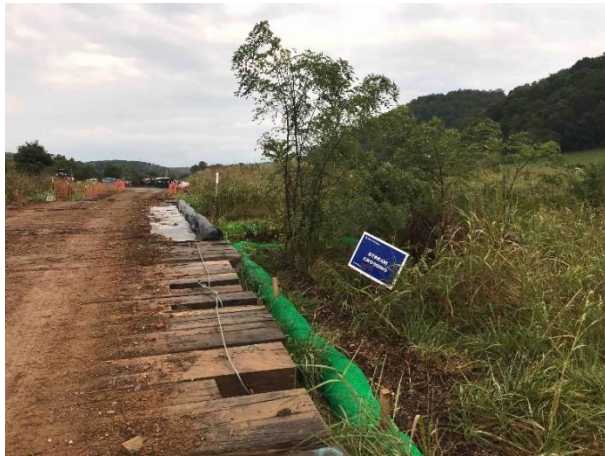
- Figure 3: Designated crossing S-CD12B, ECD's are in place and functioning.

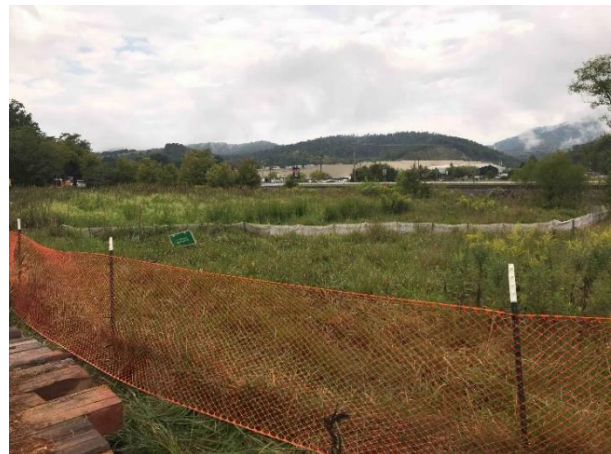
- Figure 4: Designated crossing W-CD11, ECD's are in place and functioning.
